2016 Surface Mining Inspection Report
Robertson's Ready Mix
Banning Quarry
CA Mine ID# 91-33-0012

December, 2016

Subject: 2016 Surface Mining Inspection Report
Robertson's Ready Mix "Banning Quarry"
CA Mine ID# 91-33-0012
City of Banning, Riverside County, California.

**2016 SURFACE MINING INSPECTION REPORT
ROBERTSON'S READY MIX "BANNING QUARRY"
CA MINE ID# 91-33-0012
CITY OF BANNING, CALIFORNIA**

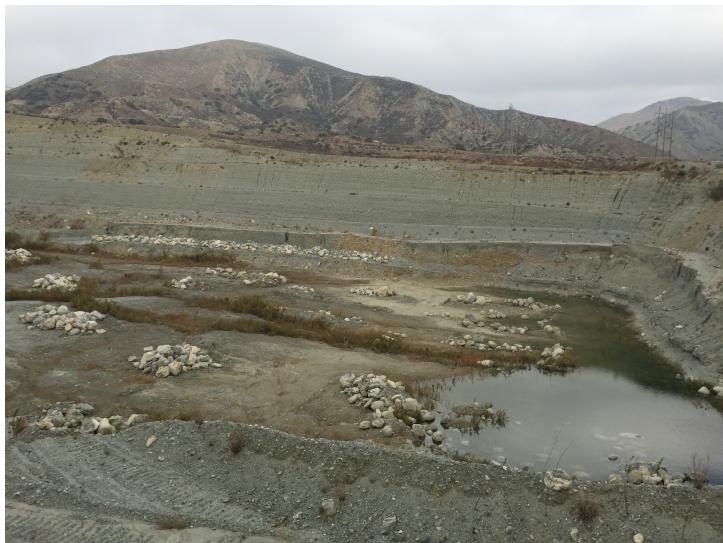
Photo 1: West Pit north-facing overview from the southeastern haul road. Rising-water conditions have remained essentially unchanged in last year. Most flows daylight near the left edge of image and collect in the pond at the eastern edge of the pit floor. Some added volunteer vegetation is apparent along small channels. View area is within permitted vested area. Scale can be judged by stockpiled boulders, most of which are 5-7+ feet in diameter. No mining or reclamation activity was started or observed in the West Pit. Haul road vehicle access is currently blocked by low soil berms.

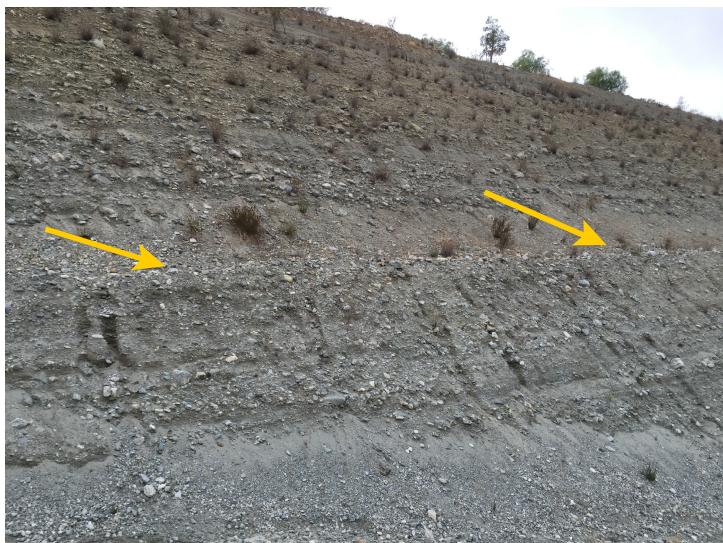
Photo 2: West Pit cut slope and partially buried bench (arrows), view southwest. Incipient rills and general wind/water deflation of the surface are beginning to become more visible. Coarse gravel and cobble clasts stand out in relief. Talus aprons cover parts of the bench and the slope toe along the descending pit haul road. Buckwheat and other perennial scrub species are also becoming established as volunteer vegetation. Height of slope in this view is ~60 feet.

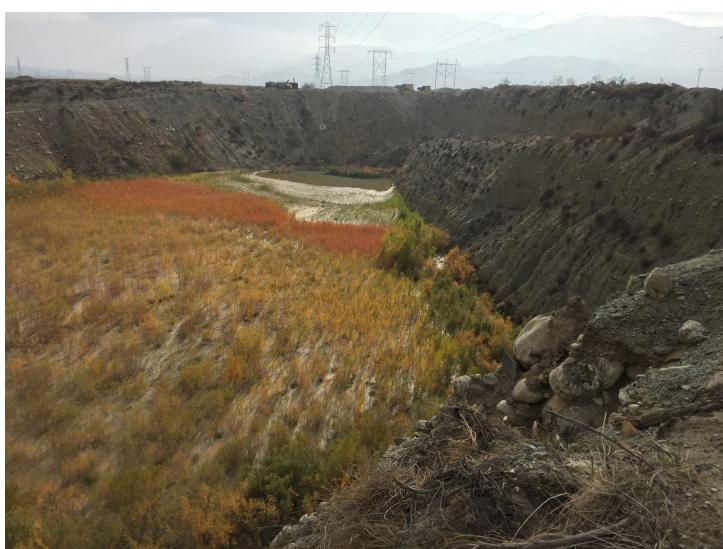
Photo 3: East Pit view to southeast, with wash-water pond and sediment-filled excavation. Except for some rise in the sediment levels, no major changes have occurred in the East Pit. SCE easement passes parallel to the right-side highwall and abandoned haul road. Some slope flattening was reportedly done in 2015 by the operator near the left side of the image. The slope is primarily loose talus. Other, near-vertical brow slopes (out of view) first reported in 2013-2014 were observed to be unchanged but remain for future reclamation tasks.

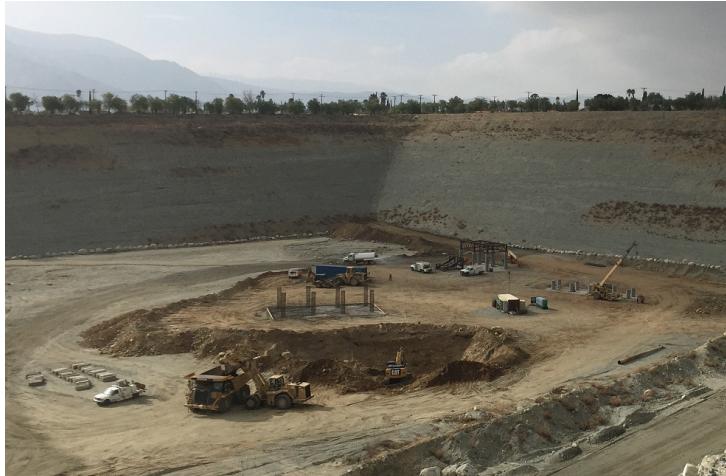
Photo 3: South Pit construction activity, view toward southwestern corner. Foundations and column erections were apparent in three locations, while excavation work for future processing machinery was proceeding in foreground. The construction was reported to be in preparation for relocation of the main rock plant. Some parts of the latter had already been dismantled and were in storage next to the "West Pit extension" pit. Information from the City of Banning indicated the pictured construction was halted by a stop-work order two days after the image date of 12-12-16. Rock plant relocation is an element of the September 19, 2016 MOU between the City and mine operator; however, the amended Mining and Reclamation Plan is incomplete and not yet an approved document. The as-built plant improvements are located in a slightly different part of the pit versus early versions of the amended Plan.

2016 Recommendations: According to current versions of the amended Reclamation Plan, pit backfills for purposes of plant relocations will *not* be implemented. Machinery and improvements would be sited directly on the very dense native soils of the South Pit floor. This construction was in fact already observed to have started

before the inspection date of December 12, 2016. The construction is not in conformance with the in-force reclamation plan, i.e., it is technically a SMARA violation, nor is the current work authorized according to *approved* amended plans even if the intent of the 2016 MOU is to ultimately allow said work. We are unsure of the proper cure for this violation. One avenue to gain (temporary) compliance may mean processing a “minor” amendment to the in-force plan approving deletion of rubble fill placement. (*N.B.* Plant relocation *was* allowed by the reclamation plan approved for UUP 1994-01). Mine plan changes that are not substantial deviations can be processed administratively without public hearings or council votes. The Lead Agency makes this determination. We think that this minor amendment approach passes qualification tests presented in the California Code of Regulations. A proper drawing illustrating the affected area should accompany a letter petition by Robertson’s. An approved minor amendment should be sent to the State Department of Conservation for the State’s mine file. The permanent compliance solution lies with completion of all terms of the MOU. The milestone date for the execution of all elements of the MOU is September 1, 2018.

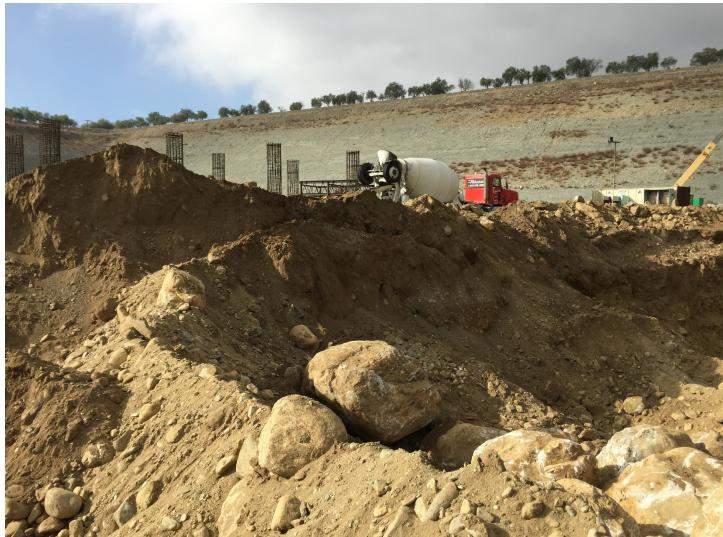
Photo 4: Closer view of under-construction rock plant relocation site, view southwest. Yellowish tones to the excavated alluvial sediments indicate greater geologic age and higher fines contents than most mined sediments. Transit mix truck arrived during the inspection visit.

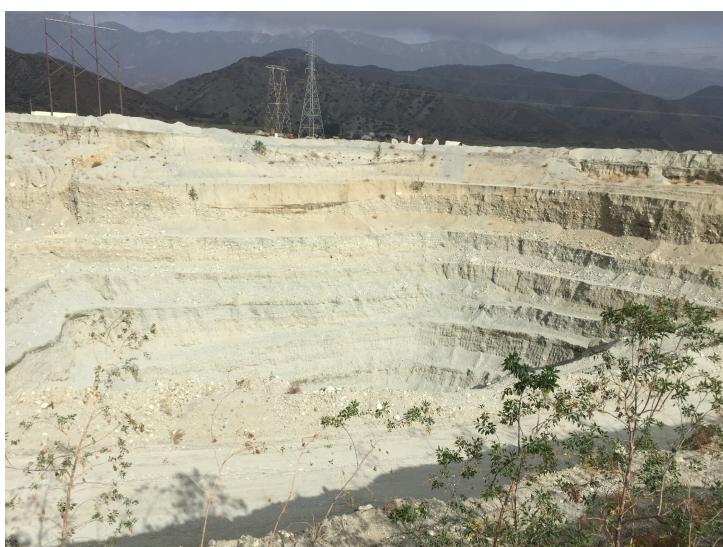
Photo 6: "West Pit extension" view to northeast, with SCE circuits shown in background. These 220kV circuits will be upgraded and relocated, with a projected completion date of 2020 per the CPUC. The pictured pit was idle. Further mining was judged improbable until interfering plant facilities and/or the circuits can be relocated. Aggregate resources identified in the 2016 MOU include the Repplier Road septum between this pit and South Pit (foreground materials) in addition to alluvium currently under the existing plant (out-of-view to the left). All slopes shown would be considered temporary.

Potential hazard to electrical transmission lines from nearby steep slopes remains, but the utility owner SCE does not appear concerned about risks. Situation is expected to be completed resolved by circuit relocations under the "West of Devers" upgrade project. Project should start construction in 2017 for eventual completion in 2020 per CPUC.
